**Flood Control Project Maintenance
Levee Inspections**
LMA District Cover Sheet
Spring 2018 Levee Inspection Results

Reclamation District No. 0785 Driver

Levee Inspection Report By Mile - Spring 2018

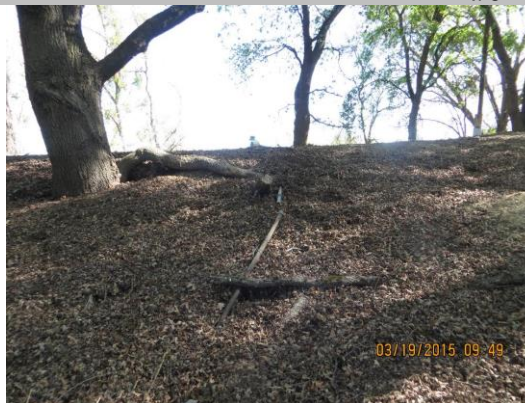
Photo 1 of 2 : UCIP_SP_2018_43965_73439.jpg

LM Start	0.00	Rating **	M	Issue No.	357
LM End	0.00	Issue Type +	En	Location *	
Category	Supplemental			GPS Latitude/Longitude	
				Start	End
Item	DWR UCIP Field Study			38.654407 °	38.654407 °
				-121.605937 °	-121.605937 °
DWR ID					
Comment Code					
Inspector Comment					
FS_ID:43965					
DS_ID:22976					
EP_NO: N/A					
Repair Type: Non-Urgent					
Crossing Status: Found					
UCIP Comments: Pipe appears abandoned and should be done so properly.					
FIELD_STRUCT_DESC: 1 of 2: 12-inch steel irrigation discharge pipe through the levee, 11 feet below the crown. Slant pump on the waterside (WS) slope. Pipe crosses under highway fill and discharges into an irrigation ditch. [Additional Reference(s): DWR Levee Log, 1988].					
FS Date: 3/19/2015

Pipe visible on LS slope.

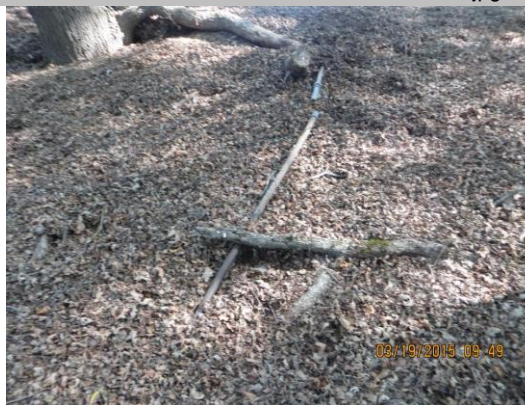
Photo 2 of 2 : UCIP_SP_2018_43965_73438.jpg

Pipe visible on LS slope.

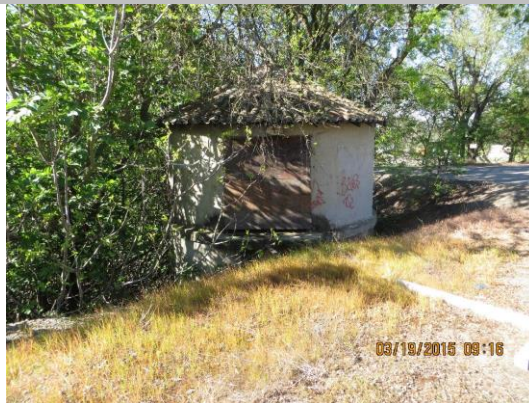
Photo 2 of 3 : UCIP_SP_2018_50617_73401.jpg

Pumphouse on LS shoulder.

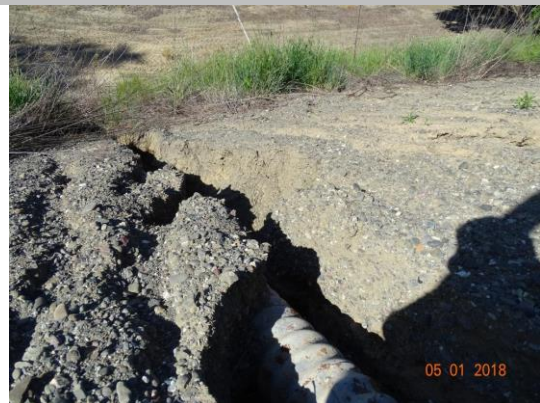
Photo 1 of 3 : SP_2018_RD0785_185_9_20180501_00053.jpg

LM Start	0.11	Rating **	U	Issue No.	9
LM End	0.11	Issue Type +	Ma	Location *	LS
Category	Earthen Levee			GPS Latitude/Longitude	
				Start	End
Item	Erosion / Bank Caving			38.660211 °	38.660211 °
				-121.611748 °	-121.611748 °
DWR ID	DWR_RD0785_01_f_2017_9				
Comment Code					
E2 : Schedule repair of erosion site prior to the next inspection.					
Inspector Comment					
Runoff erosion on landside slope that has gotten worse. The corrugated pipe is now exposed.

Updated view of runoff on the landside slope. Spring 2018.

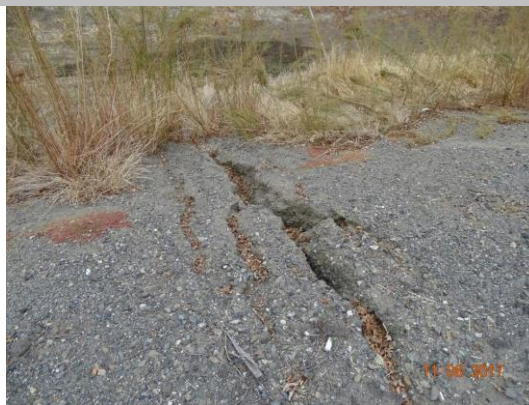
Photo 3 of 3 : SP_2018_RD0785_185_9_20180306_00006.jpg

View of runoff erosion on the landside slope. Fall 2017.

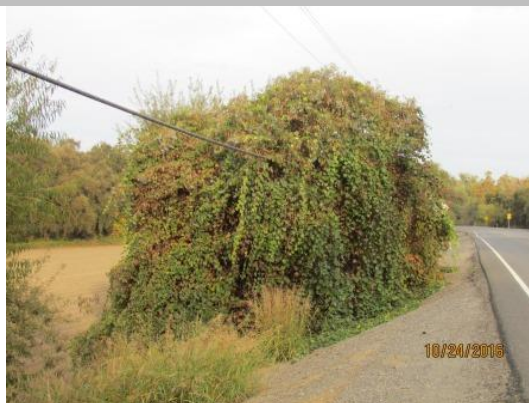
Photo 1 of 1 : SP_2018_RD0785_185_1_20180306_00001.jpg

LM Start	0.28	Rating **	A/W	Issue No.	1
LM End	0.28	Issue Type +	Ma	Location *	LS
Category	Earthen Levee			GPS Latitude/Longitude	
				Start	End
Item	Vegetation			38.658467 °	38.658467 °
				-121.609573 °	-121.609573 °
DWR ID	DWR_RD0785_01_s_2012_1				
Comment Code					
V4 : Elderberries are blocking visibility and flood fight capability.					
Inspector Comment

Elderberry tree on LS slope. Fall 2016.

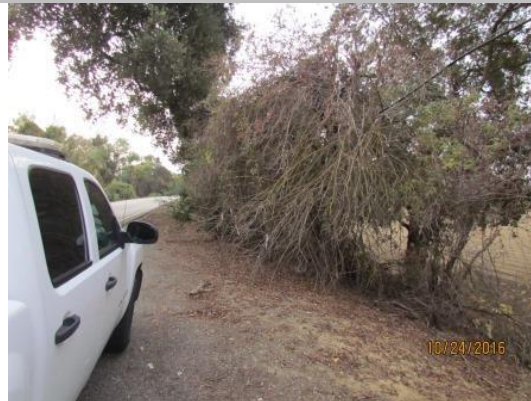
Photo 1 of 1 : SP_2018_RD0785_185_2_20180306_00002.jpg

Elderberry tree on LS slope. Fall 2016.

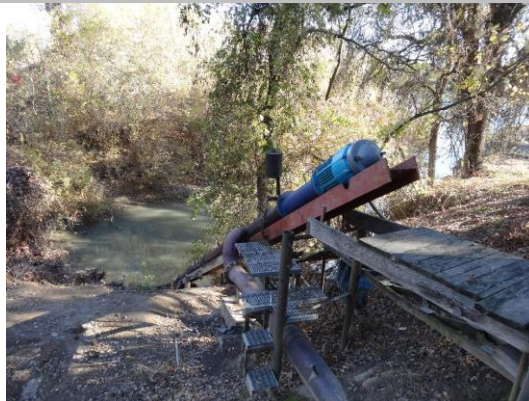
Photo 2 of 3 : UCIP_SP_2018_43963_45627.jpg

LM Start	0.63	Rating **	M	Issue No.	359 (cont)	
LM End	0.63	Issue Type +	En	Location *		
Category	Supplemental			GPS Latitude/Longitude		
				Start	End	
Item	DWR UCIP Field Study			38.654641 °	38.654641 °	
				-121.605538 °	-121.605538 °	
DWR ID						
Comment Code						
Inspector Comment						
FS_ID:43963						
DS_ID:22982						
EP_NO: N/A						
Repair Type: Non-Urgent						
Crossing Status: Found						
UCIP Comments: Part of abandoned pipe also found on waterside that should be removed.No access to landside across the highway.						
FIELD_STRUCT_DESC: 2 of 2: 0.75-inch steel electrical conduit through the levee, 1 foot below the crown. [Additional Reference(s): DWR Levee Log, 1988].						
FS Date: 11/21/2013

WS view: slant pump and walkway on levee slope.

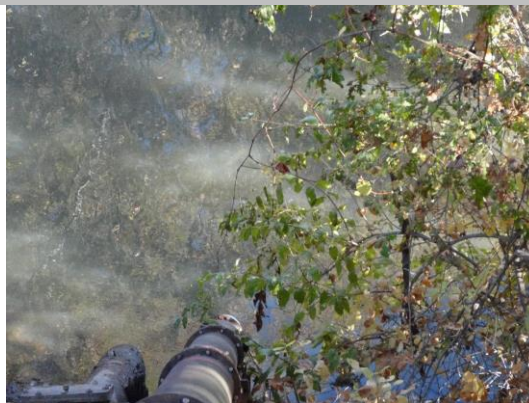
Photo 3 of 3 : UCIP_SP_2018_43963_45626.jpg

WS view: two steel pipes on levee slope. Abandoned pipe on left.

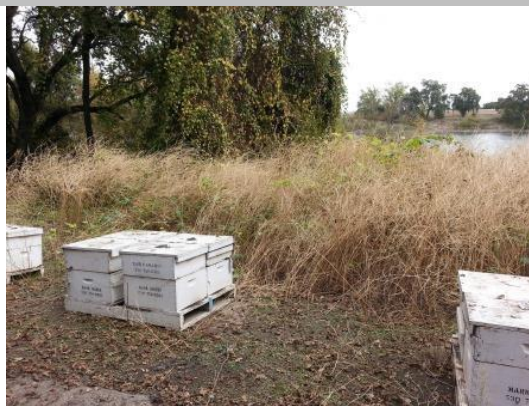
Photo 1 of 1 : SP_2018_RD0785_185_51_20180306_00035.jpg

View of vegetation site on WS slope. Fall 2016.

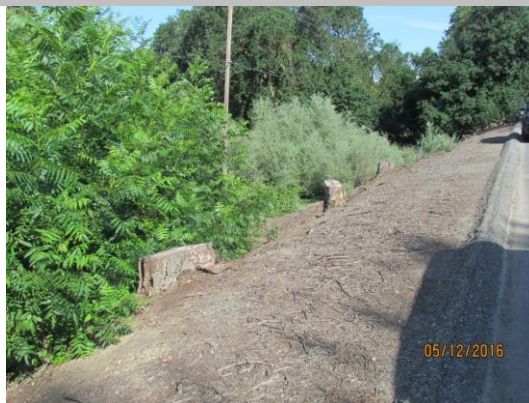
Photo 1 of 1 : SP_2018_RD0785_185_181_20180306_00037.jpg

View of the tree stumps on the landward side of the levee looking upstream. Spring 2016.

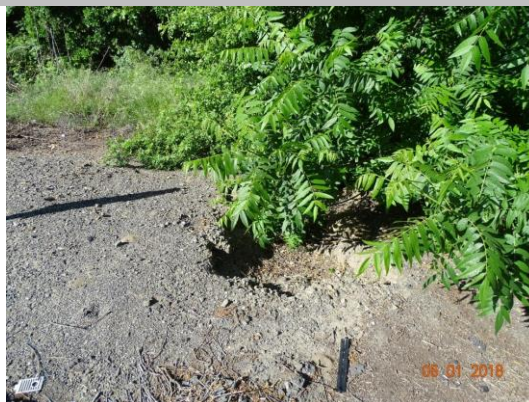
Photo 1 of 1 : SP_2018_RD0785_185_4_20180501_00054.jpg

LM Start	0.77	Rating **	A/W	Issue No.	4
LM End	0.77	Issue Type +	Ma	Location *	LS
Category	Earthen Levee			GPS Latitude/Longitude	
				Start	End
Item	Erosion / Bank Caving			38.652825 °	38.652825 °
				-121.604920 °	-121.604920 °
DWR ID	DWR_RD0785_01_s_2018_4				
Comment Code					
E1 : Note and monitor erosion site.					
Inspector Comment					
Minor runoff on landside slope. Recommend monitoring.

View of runoff erosion on the landside slope. Spring 2018.

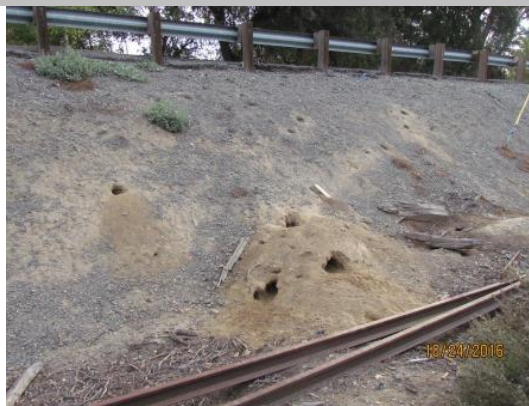
Photo 1 of 2 : SP_2018_RD0785_185_29_20180306_00019.jpg

LM Start	1.02	Rating **	M	Issue No.	29
LM End	1.02	Issue Type +	Ma	Location *	LS
Category	Earthen Levee			GPS Latitude/Longitude	
				Start	End
Item	Animal Control			38.649798 °	38.649798 °
				-121.602373 °	-121.602373 °
DWR ID	DWR_RD0785_01_f_2016_29				
Comment Code					
A3 : No rodents visible, but rodent burrows visible; need to backfill and compact or grout burrows.					
Inspector Comment					
Rodent holes on the landside slope.

View of rodent holes on LS slope. Fall 2016.

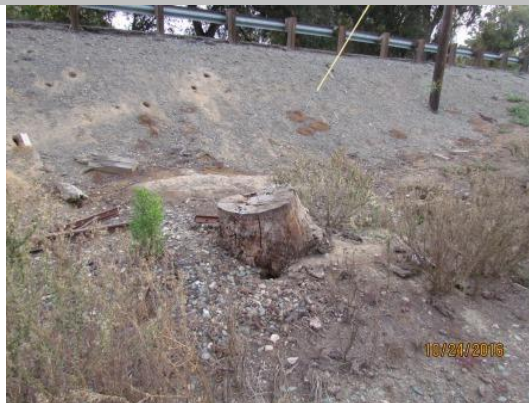
Photo 1 of 1 : SP_2018_RD0785_185_30_20180306_00021.jpg

View of a decomposing stump near levee toe on landside. Fall 2016.

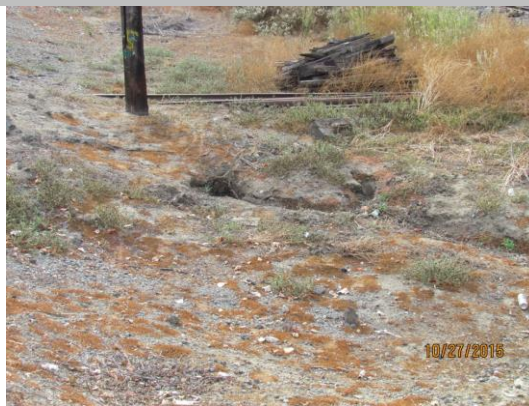
Photo 1 of 3 : SP_2018_RD0785_185_48_20180306_00031.jpg

LM Start	1.07	Rating **	M	Issue No.	48
LM End	1.07	Issue Type +	Ma	Location *	LS
Category	Earthen Levee			GPS Latitude/Longitude	
				Start	End
Item	Erosion / Bank Caving			38.649392 °	38.649392 °
				-121.601636 °	-121.601636 °
DWR ID	DWR_RD0785_01_s_2012_48				
Comment Code					
E2 : Schedule repair of erosion site prior to the next inspection.					
Inspector Comment

View of the erosion at the toe of the levee on the landward side of the levee looking downstream. Fall 2015.

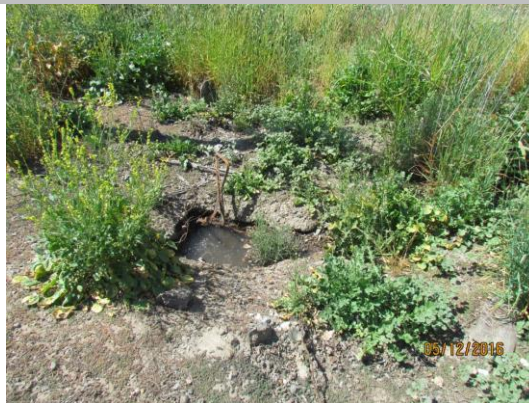
Photo 2 of 3 : SP_2018_RD0785_185_48_20180306_00032.jpg

Drain pipe is causing erosion on the landward side of the levee between the Isope and railroad tracks. Spring 2016.

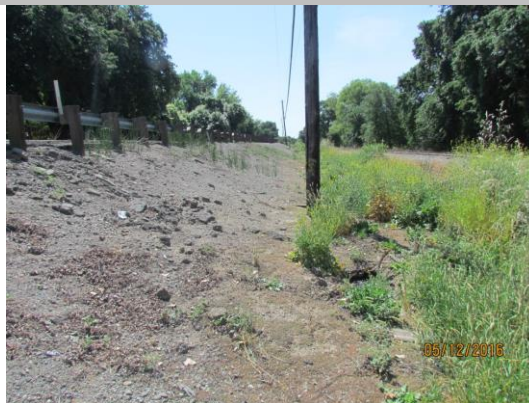
Photo 3 of 3 : SP_2018_RD0785_185_48_20180306_00033.jpg

LM Start	1.07	Rating **	M	Issue No.	48 (cont)	
LM End	1.07	Issue Type +	Ma	Location *	LS	
Category	Earthen Levee			GPS Latitude/Longitude		
				Start		End
Item	Erosion / Bank Caving			38.649392 °		38.649392 °
				-121.601636 °		-121.601636 °
DWR ID	DWR_RD0785_01_s_2012_48					
Comment Code						
E2 : Schedule repair of erosion site prior to the next inspection.						
Inspector Comment

Perspective view of the erosion on the landward side of the levee looking downstream. Spring 2016.

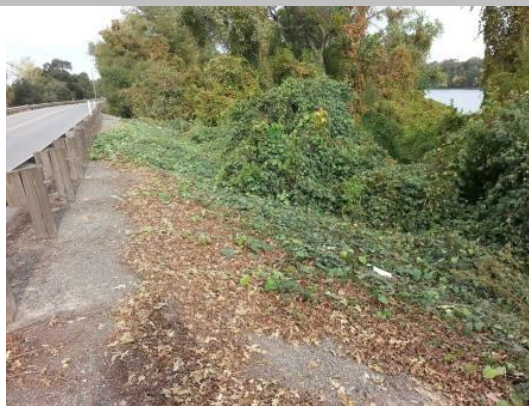
Photo 1 of 2 : SP_2018_RD0785_185_44_20180306_00028.jpg

Elderberry trees on WS slope Fall 2016.

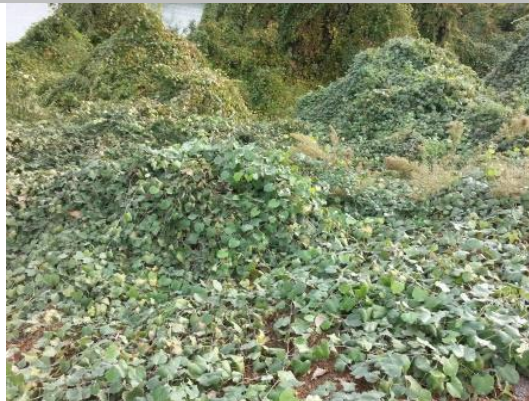
Photo 2 of 2 : SP_2018_RD0785_185_44_20180306_00029.jpg

Elderberry trees on WS slope. Fall 2016.

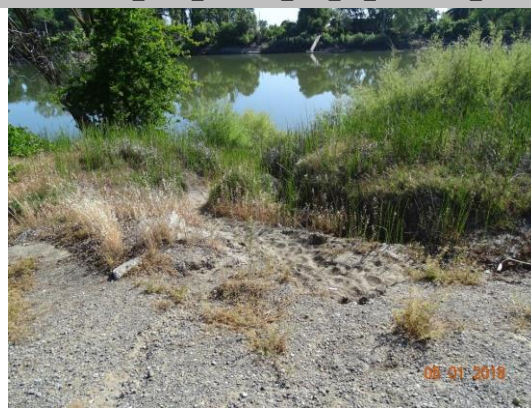
Photo 1 of 4 : SP_2018_RD0785_185_13_20180501_00051.jpg

LM Start	1.31	Rating **	M	Issue No.	13
LM End	1.31	Issue Type +	Ma	Location *	WS
Category	Earthen Levee			GPS Latitude/Longitude	
				Start	End
Item	Slope Stability			38.646652 °	38.646652 °
				-121.598907 °	-121.598907 °
DWR ID	DWR_RD0785_01_s_2013_13				
Comment Code					
S2 : Repair the levee slope damaged by foot traffic and prevent access where possible.					
Inspector Comment					
Footpath still visible on the waterside slope.

Updated view of slope stability on the waterside slope. Spring 2018.

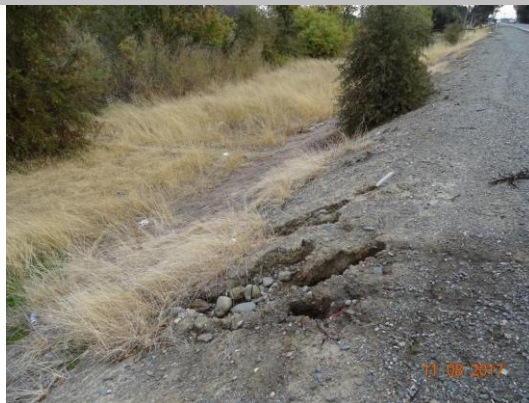
Photo 1 of 1 : SP_2018_RD0785_185_55_20180306_00036.jpg

LM Start	1.51	Rating **	M	Issue No.	55
LM End	1.51	Issue Type +	Ma	Location *	WS
Category	Earthen Levee			GPS Latitude/Longitude	
				Start	End
Item	Erosion / Bank Caving			38.644349 °	38.644349 °
				-121.596506 °	-121.596506 °
DWR ID	DWR_RD0785_01_f_2017_55				
Comment Code					
E2 : Schedule repair of erosion site prior to the next inspection.					
Inspector Comment					
Runoff on waterside slope.

View of the runoff erosion on the waterside slope. Fall 2017.

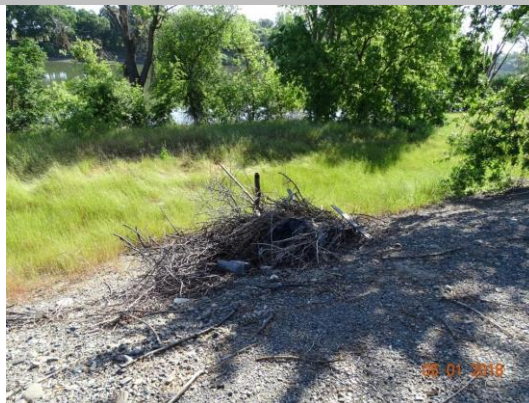
Photo 1 of 1 : SP_2018_RD0785_185_25_20180501_00050.jpg

View of pruning pile on the waterside slope. Spring 2018.

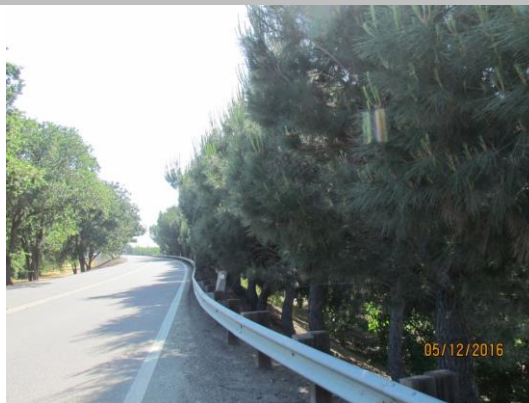
Photo 1 of 1 : SP_2018_RD0785_185_8_20180306_00005.jpg

View of the pines on the shoulder of the landward side of the levee looking downstream. Spring 2016.

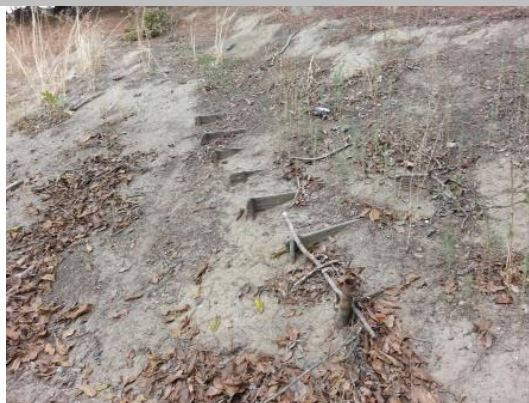
Photo 1 of 1 : SP_2018_RD0785_185_41_20180306_00027.jpg

View of old abandoned stairway on LS slope. Fall 2016.

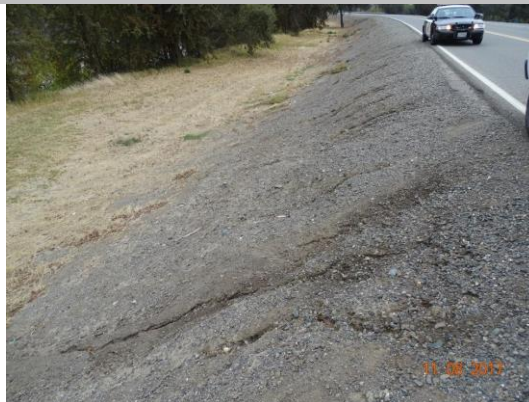
Photo 1 of 1 : SP_2018_RD0785_185_19_20180306_00014.jpg

LM Start	2.23	Rating **	A/W	Issue No.	19
LM End	2.23	Issue Type +	Ma	Location *	WS
Category	Earthen Levee			GPS Latitude/Longitude	
				Start	End
Item	Erosion / Bank Caving			38.642908 °	38.642908 °
				-121.584647 °	-121.584647 °
DWR ID	DWR_RD0785_01_s_2018_19				
Comment Code					
E1 : Note and monitor erosion site.					
Inspector Comment					
Runoff erosion on waterside slope. Recommend monitoring.

View of runoff erosion on the waterside slope. Fall 2017.

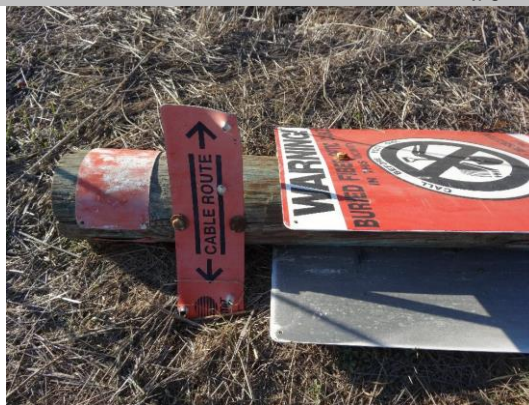
Photo 2 of 2 : UCIP_SP_2018_24750_44371.jpg

LS view: closer view of damaged indicator post.

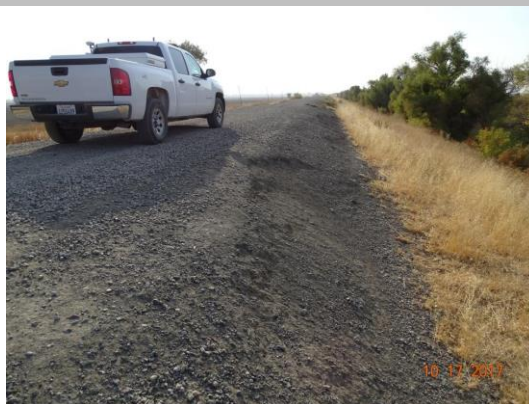
Photo 1 of 1 : SP_2018_RD0785_186_7_20180306_00003.jpg

View of sloughing section on waterside hinge point. Fall 2017.

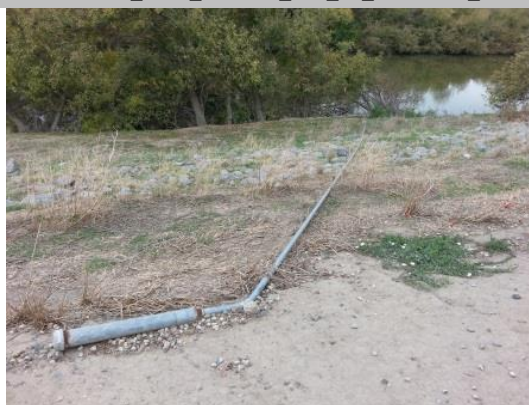
Photo 1 of 1 : SP_2018_RD0785_186_19_20180306_00005.jpg

View of a capped galvanized pipe on WS slope. Fall 2016.

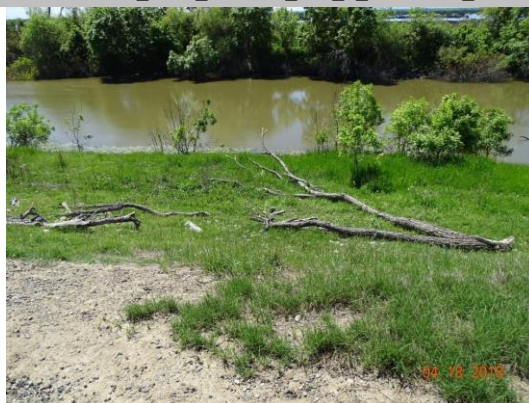
Photo 1 of 1 : SP_2018_RD0785_186_4_20180419_00010.jpg

View of tree branches on the waterside slope. Spring 2018.
